# Four trees of concern within the public R.O.W. of the Halprin Sequence

Richard Bosch, architect emeritus

June 25, 2021

This brief assessment considers four problem trees—three Lindens and one Norway Maple—that seem most likely to cause property damage, bodily injury or death, if they were to topple or break.

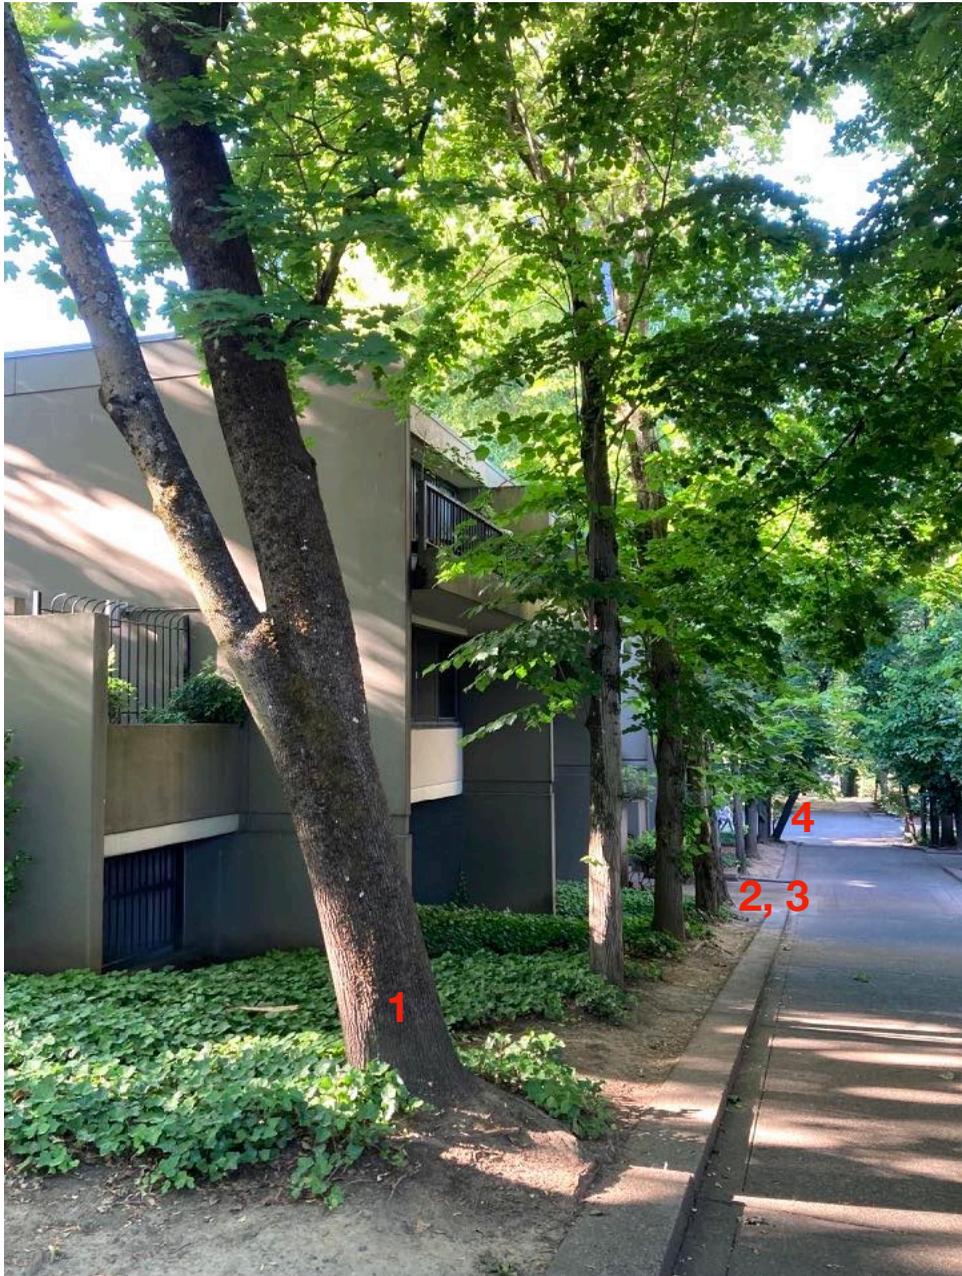
Above: The four problem trees are all on the same block, although only two of the trees, **2** and **3**, were impacted by the huge Elm that came down in 2020.  
 Right: Diagram, not to scale, showing location of the four problem trees and the ghost of the huge Elm.

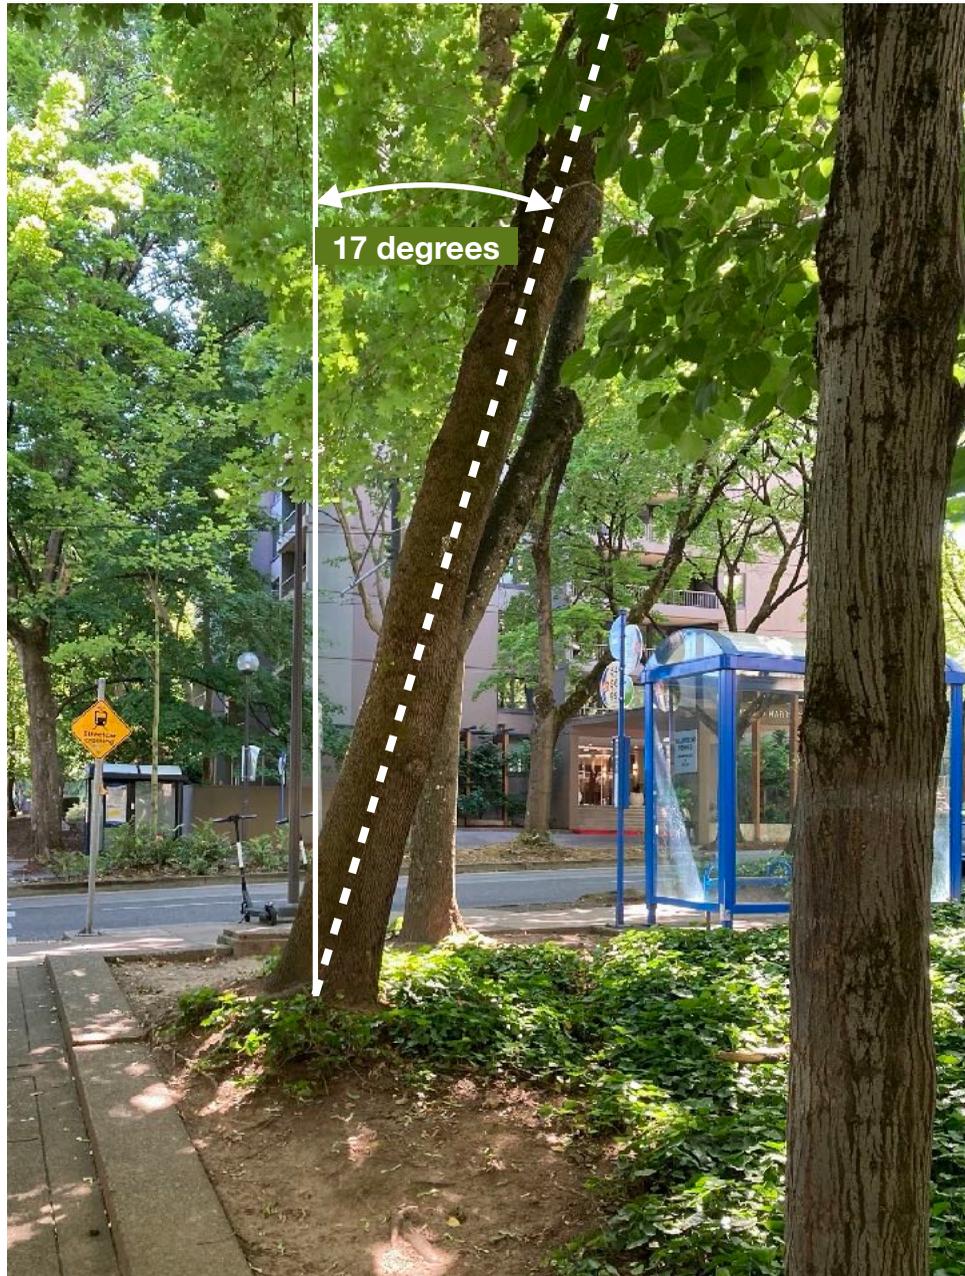
# 1 Norway Maple

Above: The 20" caliper Norway Maple listing towards the HW parking garage entrance and flagpole (not shown in this photo).

This 20" caliper Norway Maple, about 80 feet tall, is located near the southeast corner of the Harrison West property. It lists 17 degrees from vertical, for its entire height. Based on visual observation, only, some of the root structure appears to be anchored below the concrete curb [note the 1" displacement], but, it appears that the roots have not found their way below the former roadway. In other words, the concrete curb may be preventing the tree from toppling.

If this tree were to topple, it would cause the least damage. It would fall away from the pedestrian mall and it is sufficiently away from the TriMet bus shelter and the Streetcar overhead power lines.

The main trunk, requiring a chainsaw to cut into manageable pieces, would *not* reach the driveway entrance to the Harrison West property, although tributary branches and the crown would cover the driveway. The most likely damage will be to the HW flagpole.

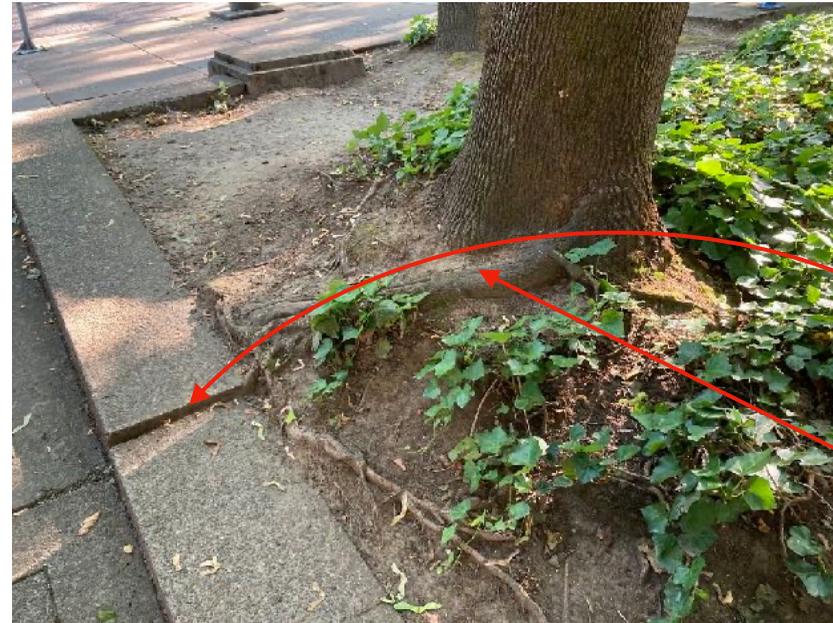
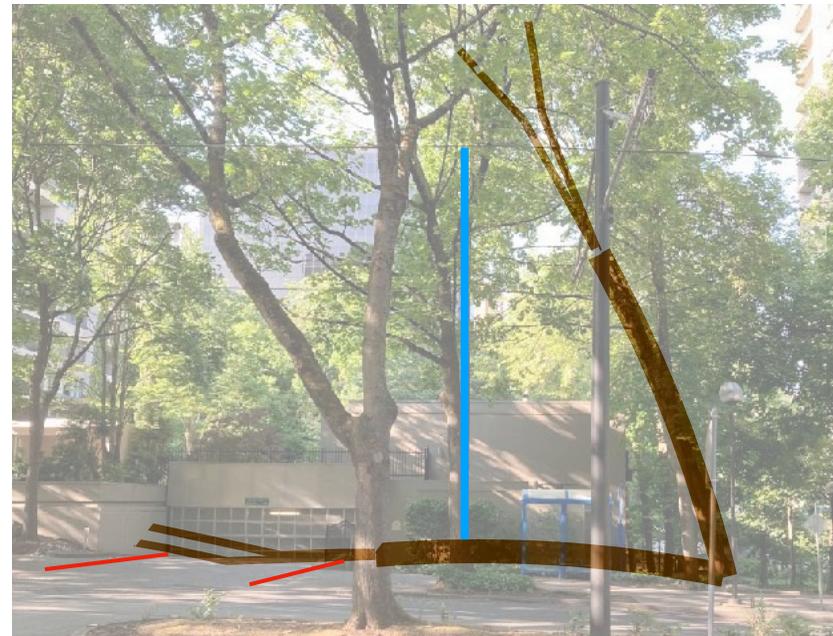
There is also evidence of "stem girdling," the tendency for roots to grow over the root flare and around the trunk of the tree.

Above: Detail of asymmetrical root structure and stem girdling. Below: Assumed direction of tree toppling—flagpole indicated in blue; driveway into parking garage, with red lines.

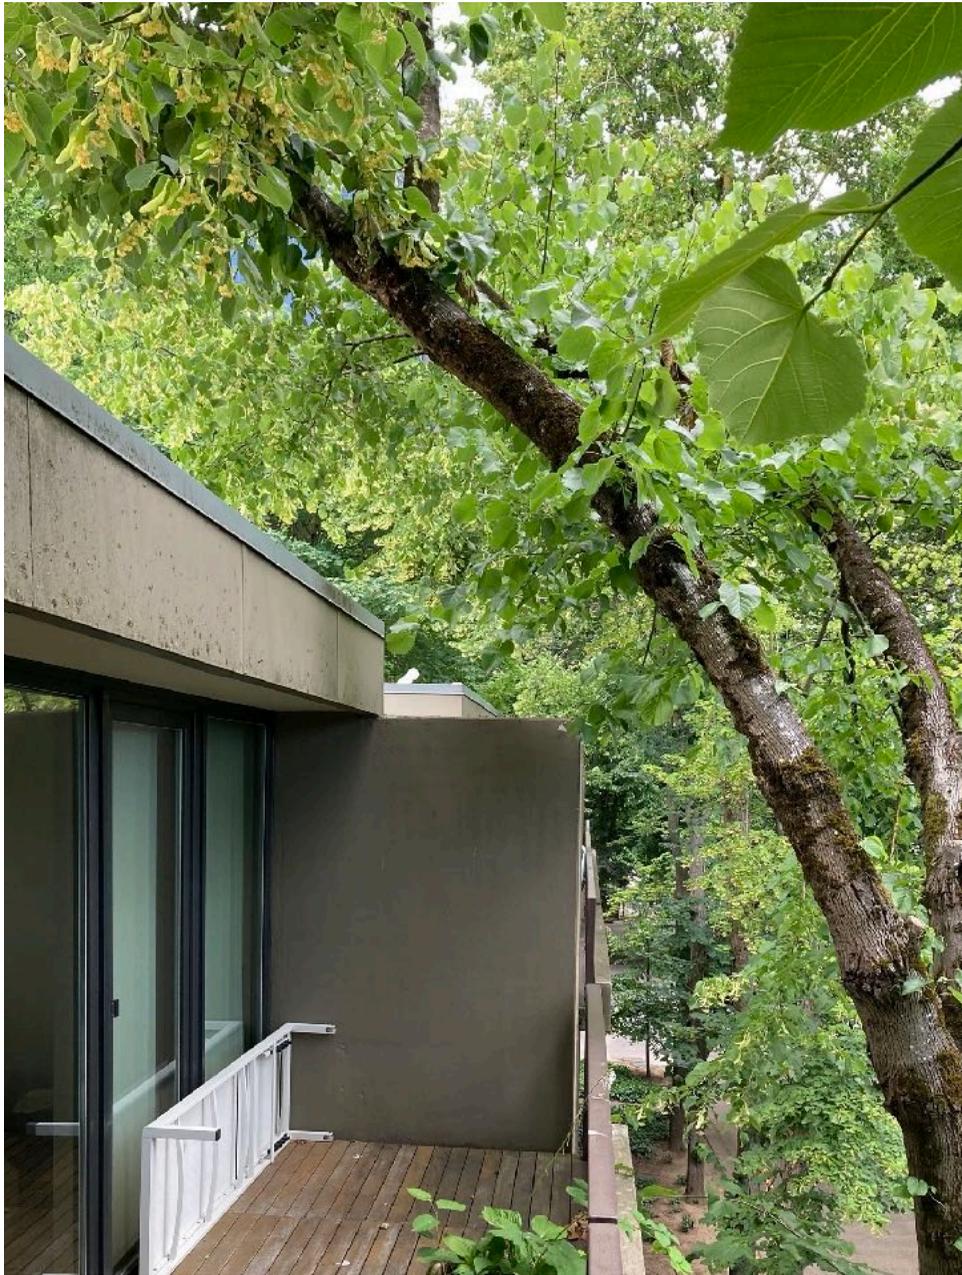
## 2, 3 Lindens

Above: The upper part of the 16" caliper Linden leans over the roof of townhome 11. The entire crown hovers over the roof and has been the source of vermin, insect infestation, and during high winds, has even toppled the metal chimney.

These 16" caliper Lindens, about 60 to 70 feet tall, located along the 2nd Ave Mall, hover over Townhome 11, of the Harrison West complex. These are among the several trees that were stunted or deformed from the huge Elm that dominated and darkened this area, until 2020. Although reasonably straight at their bases, these trees responded to the insufficient sunlight, by hanging over the roof of the townhome, so that their entire crowns are suspended over the roof.

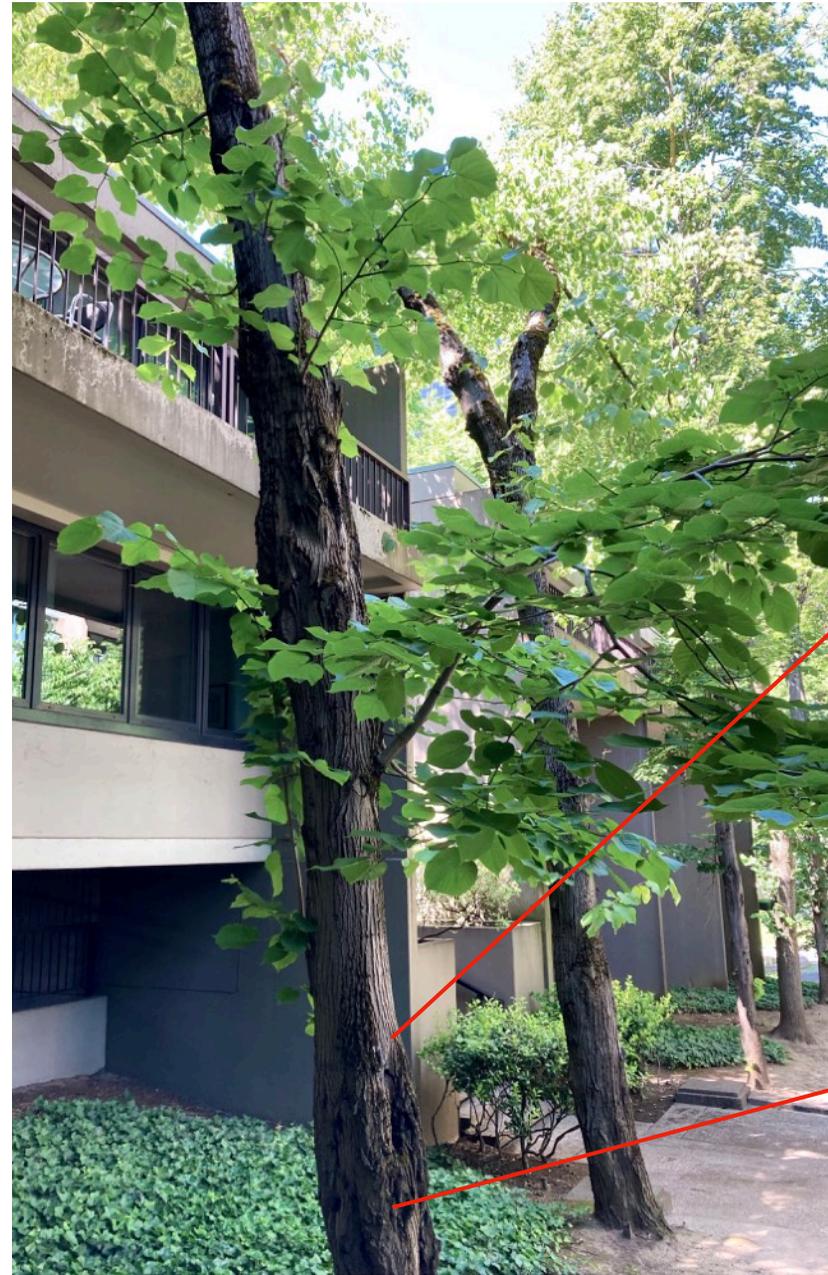
Both trees have exhibited diseased conditions for many years, but number **2** has recently developed a decay hole, that is several inches deep, about 5 feet off the ground.  
 (Most likely to cause severe structural damage.)

Above: Trees start off reasonably straight and start to bend around 30 feet above the ground. The tree in the foreground recently developed a decay hole and is showing lateral stress marks just above that hole.

Both Lindens display evidence of disease, but one of them recently developed a deep decay hole about 5 feet off the ground, with lateral stress cracks just above the new hole.

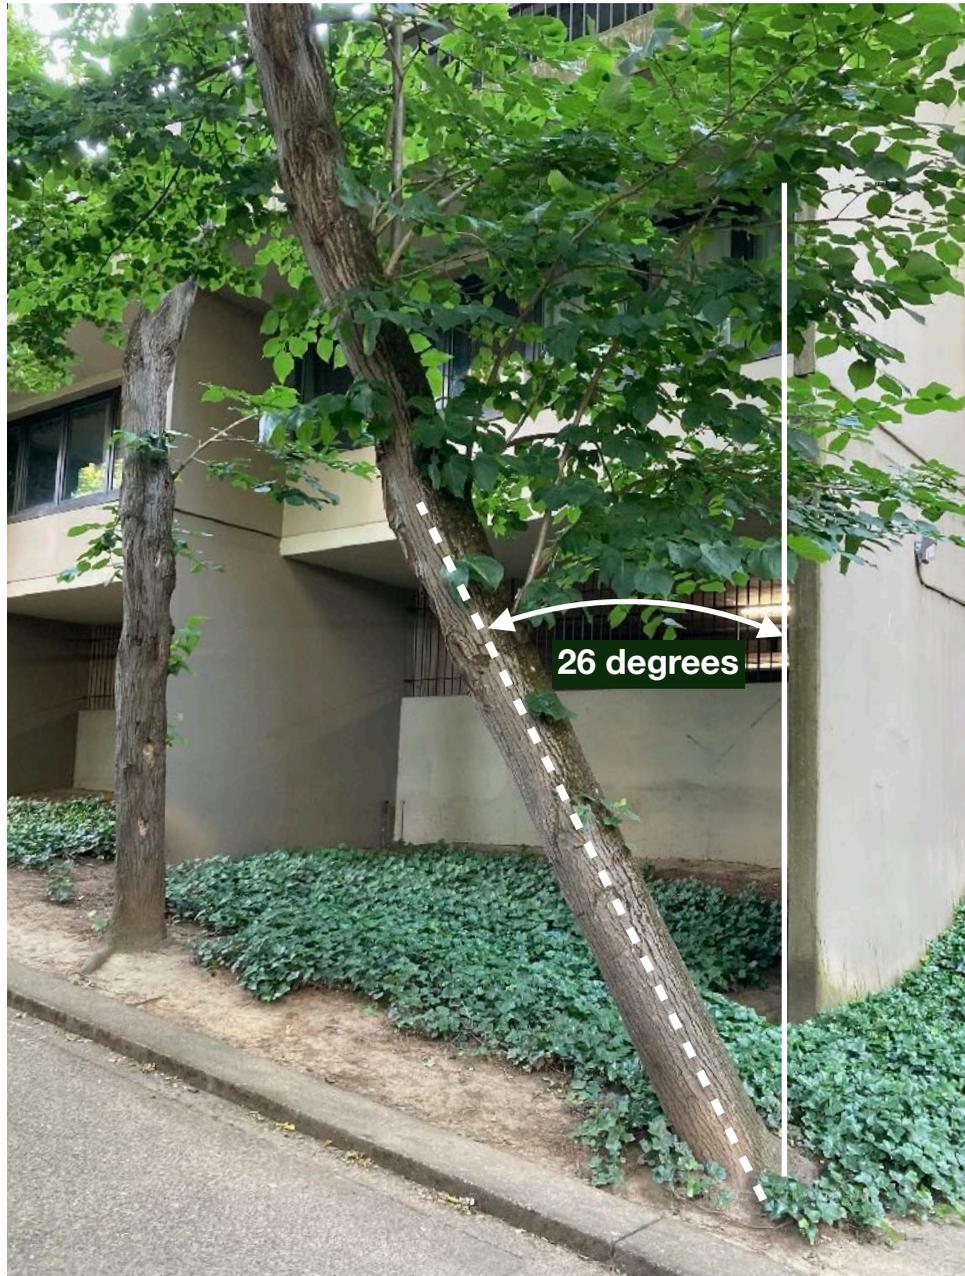
## 4 Linden

Above: The most frightening situation is this listing Linden, which appears to have nothing holding it up. There are no cracks in the adjacent sidewalk nor the curb, to suggest that roots have anchored underneath—only the girdling.

This 16" caliper Linden, about 60 to 70 feet tall, is located near the northeast corner of the Harrison West property adjacent to Pettygrove Park. It has a list of 26 degrees and, similar to the listing Norway Maple, described above, visual observation suggests that roots were not able to develop symmetrically below the roadway and the sidewalk.

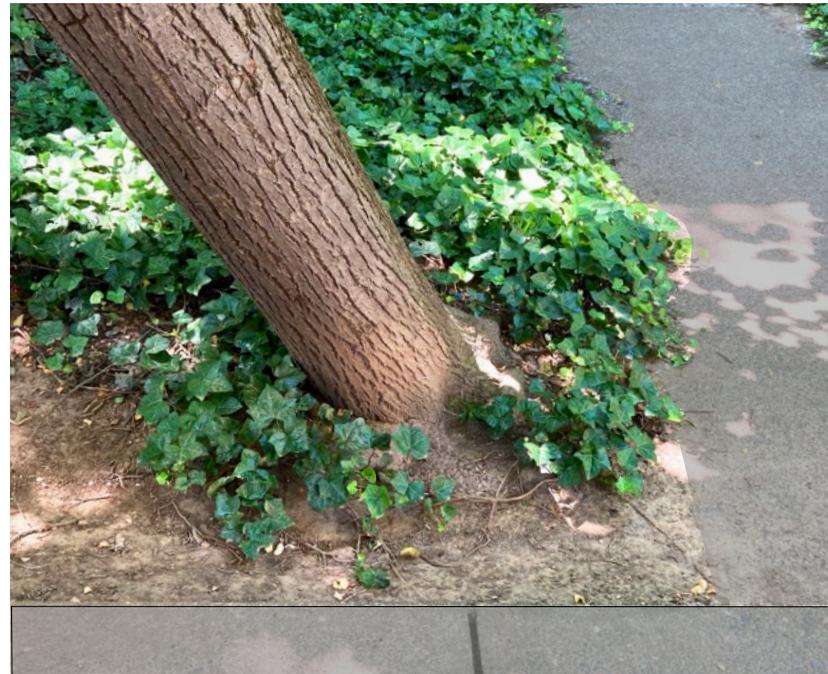
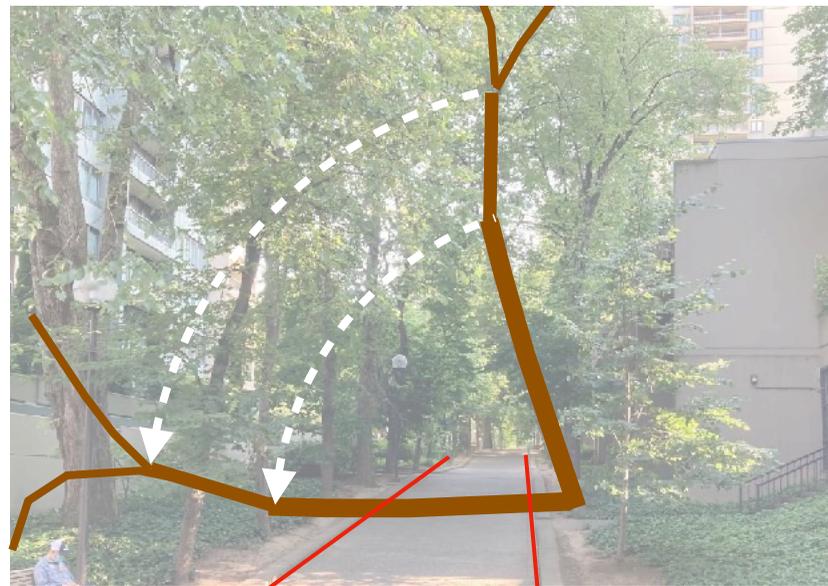
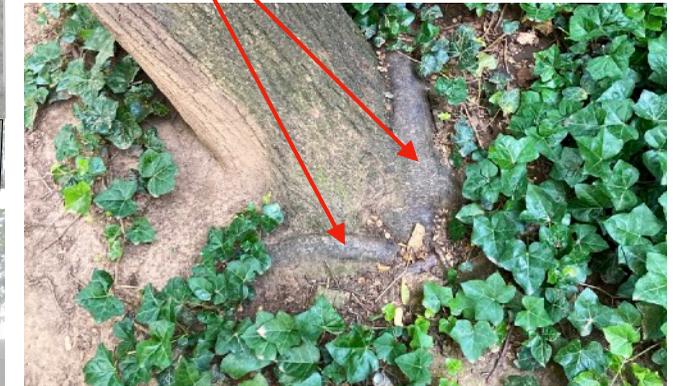
Above and above, right: Detail of asymmetrical root structure and stem girdling.  
Below: Assumed direction of tree toppling—pedestrian mall in red.

As with the Norway Maple, there is also clear evidence of stem girdling, which may be contributing to the perilous list of this tree.

If this tree were to topple, it could cause injury or death. The main section of trunk, which would require a chainsaw to reduce to manageable pieces, would fall directly across the full width of the 2nd Ave Mall. Tributary branches and the crown would fall harmlessly onto the planted area of the Harrison East condominium complex.
