# Four trees of concern within the public R.O.W. of the Halprin Sequence

Richard Bosch, architect emeritus

June 25, 2021

This brief assessment considers four problem trees—three Lindens and one Norway Maple—that seem most likely to cause property damage, bodily injury or death, if they were to topple or break.

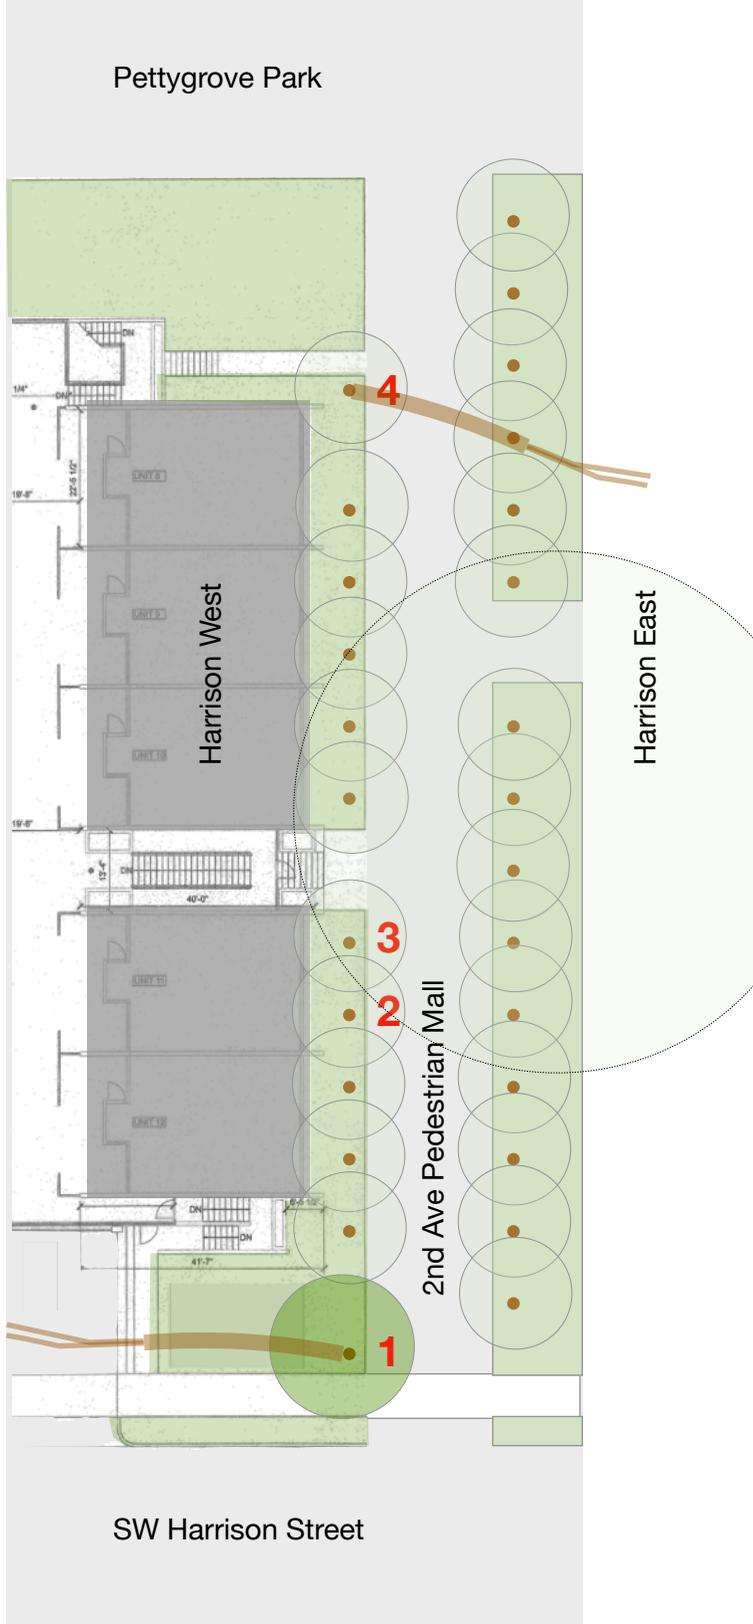
# 1 Norway Maple

**1** is a 20” caliper Norway Maple, perhaps 80 feet tall, that slopes precariously at 17 degrees, but away from the pedestrian mall. Apparently no root structure has developed towards the east, hindered by the 16” concrete curb and the former roadway.

Once toppled, the main trunk would *not* block the driveway to the Harrison West parking garage, although tributary limbs and the crown would fall across the driveway.  
 (Least likely to cause injury or structural damage.)

This 20" caliper Norway Maple, about 80 feet tall, is located near the southeast corner of the Harrison West property. It lists 17 degrees from vertical, for its entire height. Based on visual observation, only, some of the root structure appears to be anchored below the concrete curb [note the 1" displacement], but, it appears that the roots have not found their way below the former roadway. In other words, the concrete curb may be preventing the tree from toppling.

If this tree were to topple, it would cause the least damage. It would fall away from the pedestrian mall and it is sufficiently away from the TriMet bus shelter and the Streetcar overhead power lines.

The main trunk, requiring a chainsaw to cut into manageable pieces, would *not* reach the driveway entrance to the Harrison West property, although tributary branches and the crown would cover the driveway. The most likely damage will be to the HW flagpole.
